# BIANCHI HOME INSPECTIONS

## PROPERTY INSPECTION REPORT

Square feet: 2732 Year Built: 2015

Date of Inspection: 08/24/2022

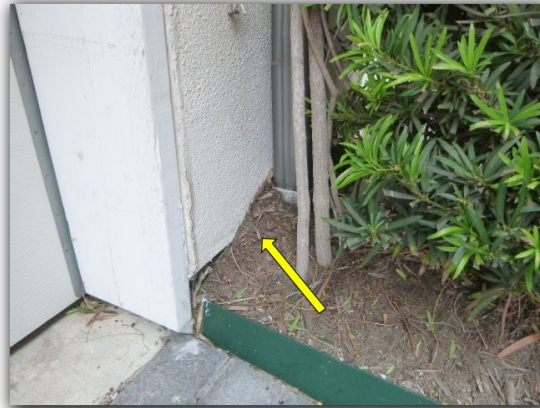
Soil level too high around areas including, but not limited to, areas around garage. Common industry practice requires a clearance of at least 4 inches from the bottom of the siding to the soil. High soil level near the siding promotes wood rot and is considered a conducive condition to termite activity and water penetration.

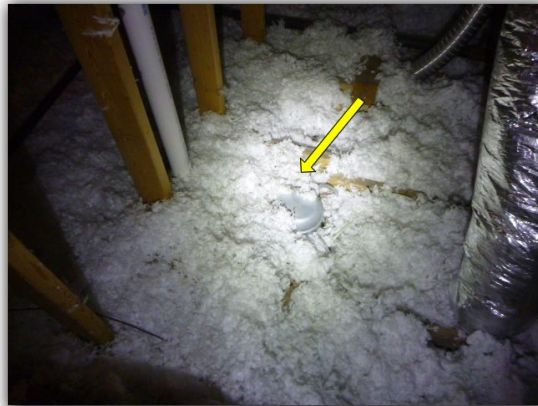
Ensure insulation has maintained a minimum of 3 inches and wood a minimum of 1 inch from around all recessed lights to reduce possible fire hazards.

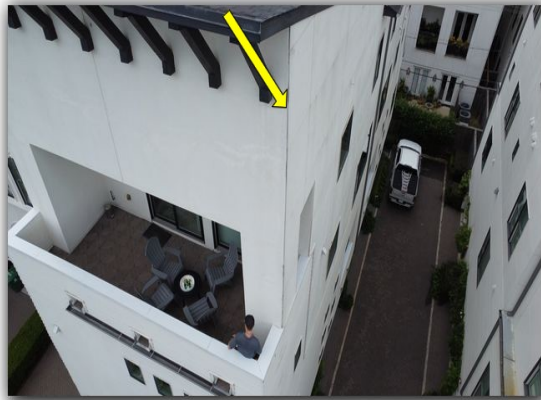
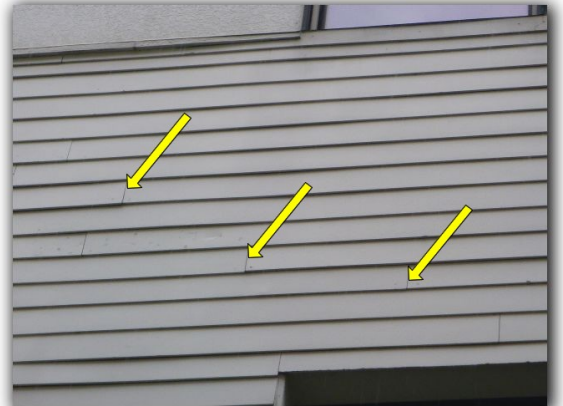
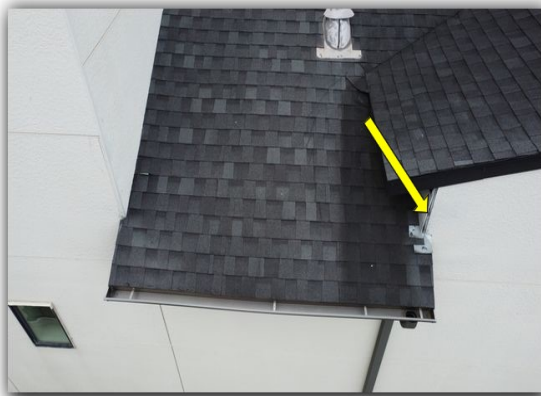
Caulking missing and/or deficient at vertical joints in the siding; may allow wind-driven rain entry.

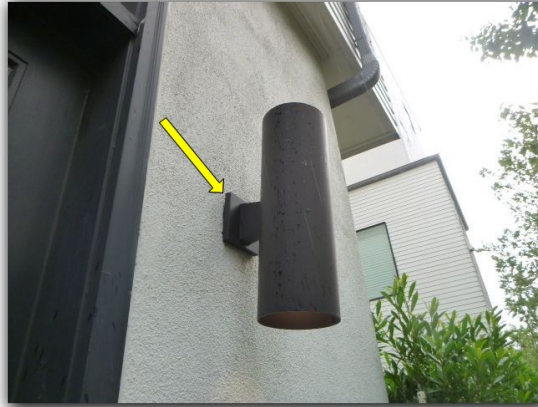
Possible water entry from cracks and/or penetrations in stucco siding, Recommend sealing/caulking around all cracks and exterior siding penetrations including but not limited to light fixtures, electrical outlets/service panels, dryer, bath vents, etc.

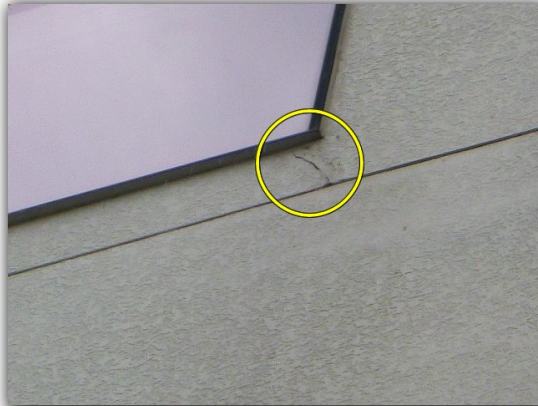
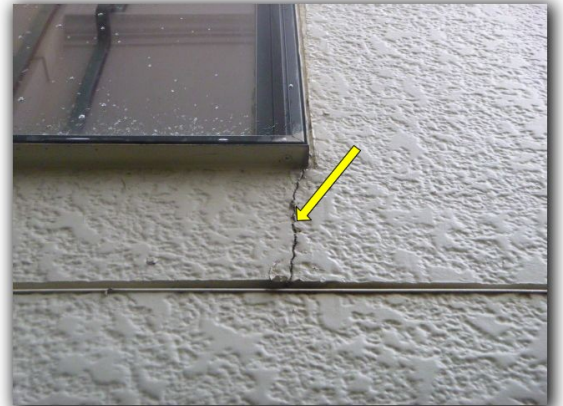
Cracked cement board siding observed at the west and east side of the house. Recommend sealing cracks to prevent potential water penetration.

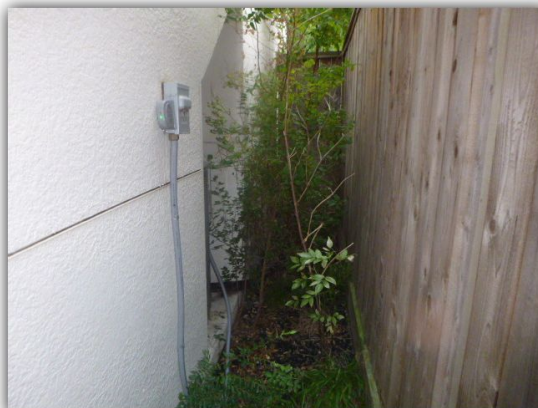
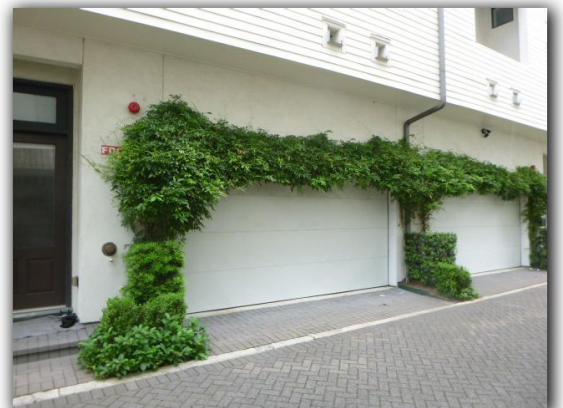
*Bushes/trees/foliage should not contact the siding of the house to prevent wood rot and/or insect access. Vines obscure view of exterior siding and foundation.*

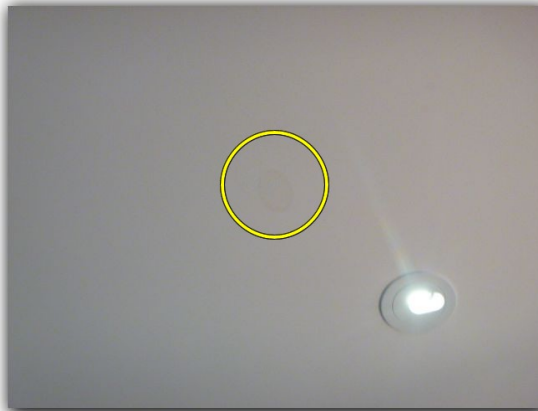
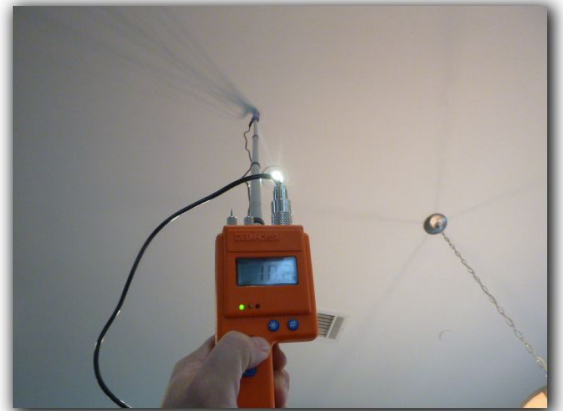
Water stains, damage or repairs observed, moisture detection equipment indicated that stains are not active (wet) at the time of inspection; dining room

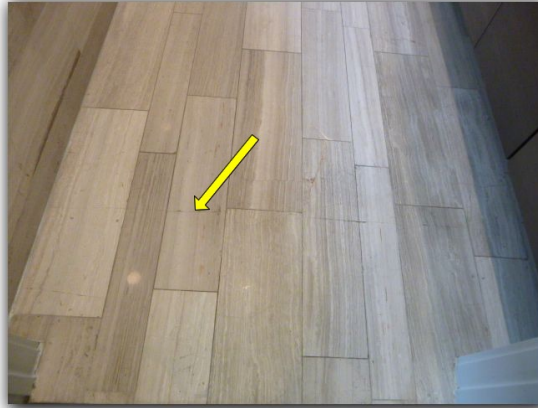
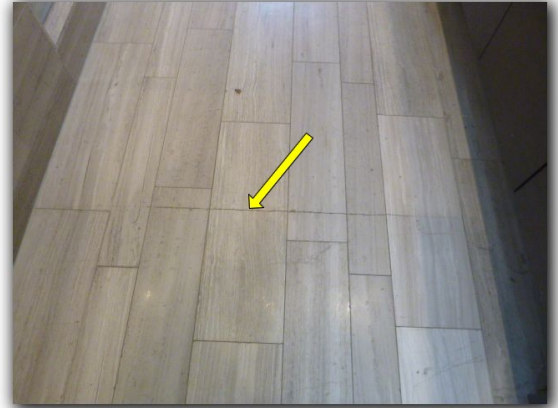
Cracked/chipped and/or loose floor tile observed in; master bathroom

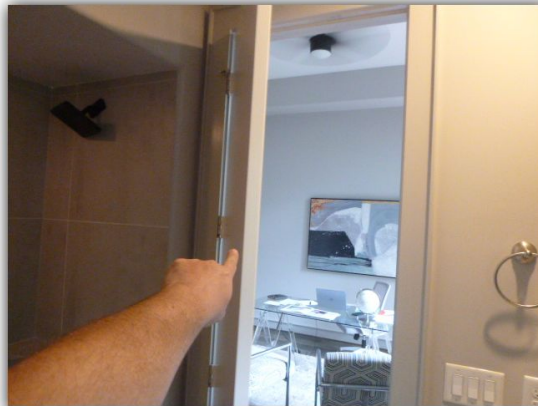
A "ghost door" was observed at one or more locations. The door is self-opening/closing. The door/jamb is not setting level/plumb. (downstairs bathroom)

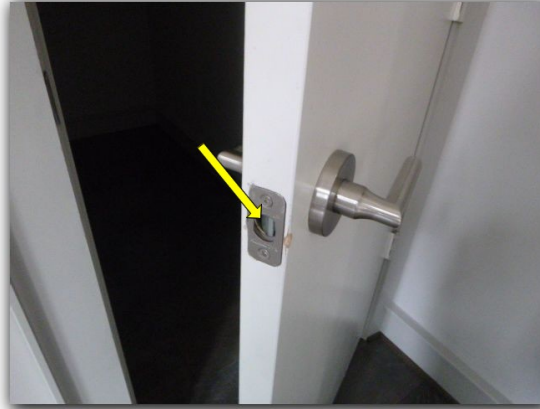
Sticky door mechanism observed. Door does not latch. (first floor bedroom closet)

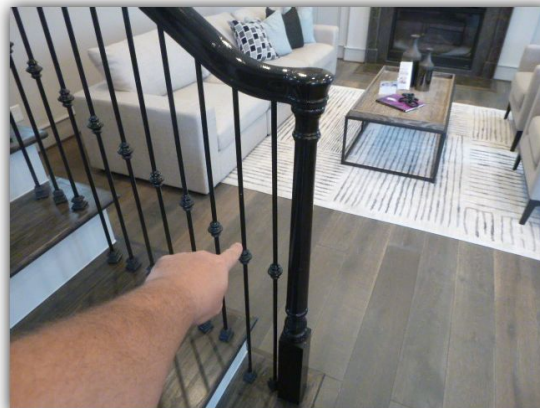
One or more loose spindles on stairway observed. (2nd to 3rd floor)

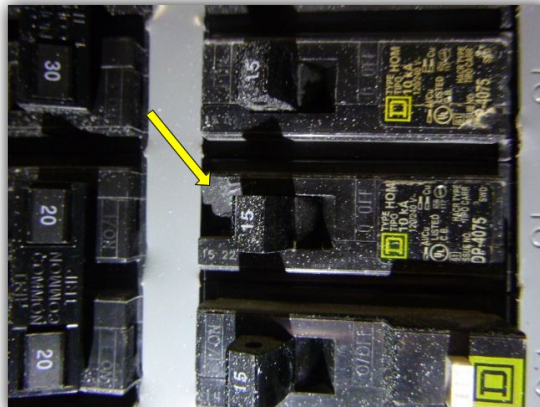
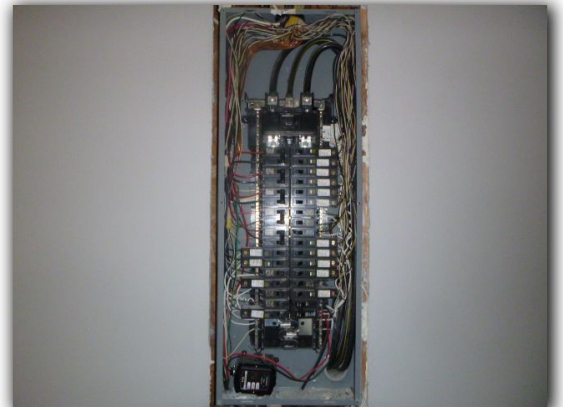
Damaged breaker observed in the panel. (breaker #18)

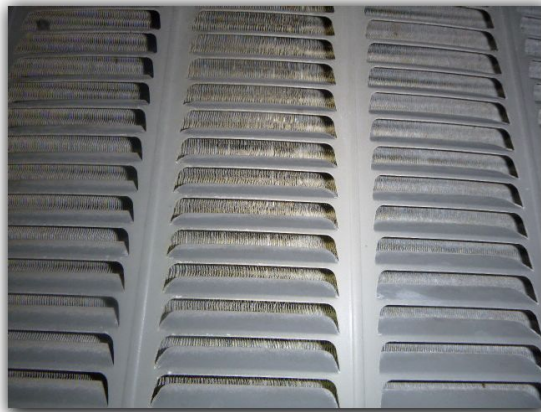
Coils are dirty, needs cleaning. Dirty coils reduce airflow through the system and create high head pressures at the compressor, thereby unduly stressing and reducing the life span of system components.

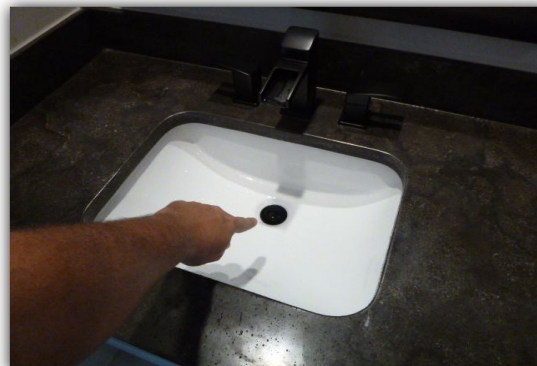
The primary drain line needs a trap near the coil to reduce noise at the plumbing fixture drain. (4th floor bathroom)

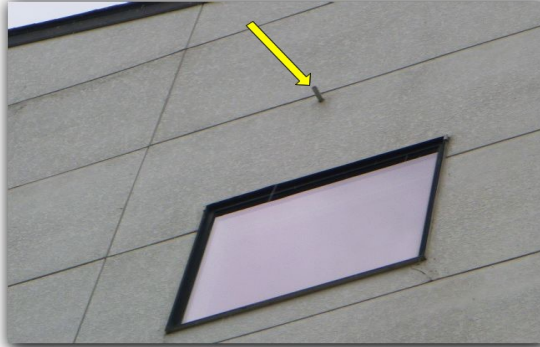
Missing 90-degree elbow fitting on end of emergency drain line to prevent condensation dripping back onto the exterior wall; east exterior

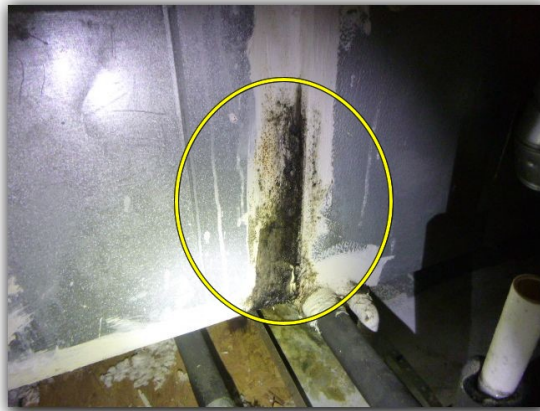
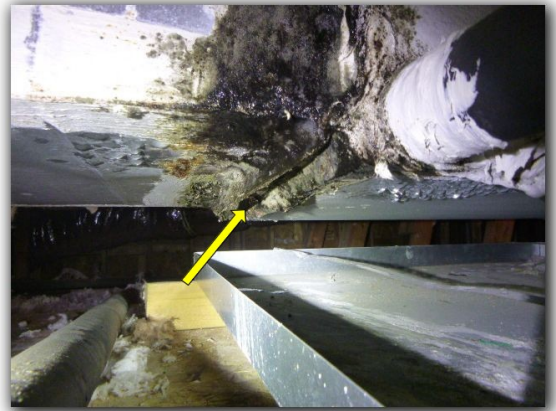
Excessive air loss around transition/coil causing microbial growth. (At base/side of evaporator coil)

- ◆ Excessive air loss around transition/coil causing microbial growth. (At base/side of evaporator coil)
- ◆ Rust stains / peeling of paint in 4th floor game room registers observed. Appears to be from excessive condensation.

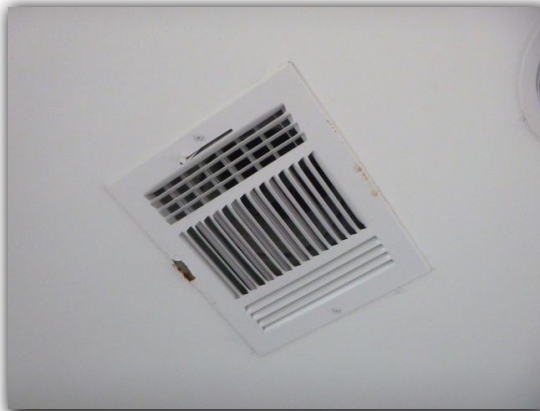
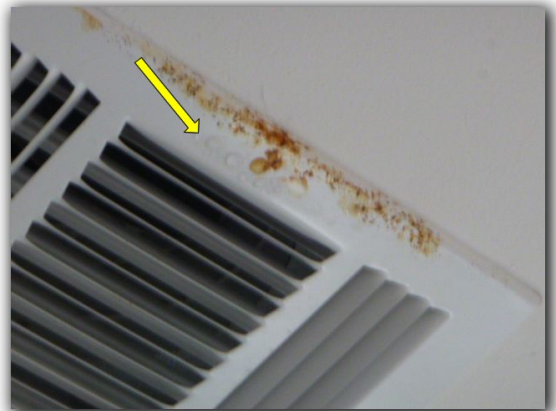
Rust stains / peeling of paint in 4th floor game room registers observed. Appears to be from excessive condensation.

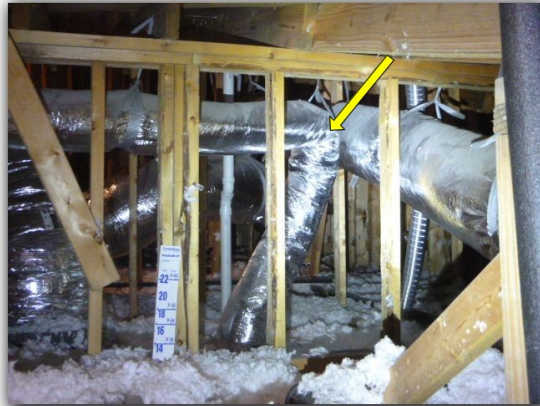
Some flex ducts observed to be improperly routed with sharp bends and/or excess material in bends. Improper routing increases frictional loss in the duct and reduces heating and cooling efficiency. Radius at the centerline of the bend should be no less than the diameter of the duct.

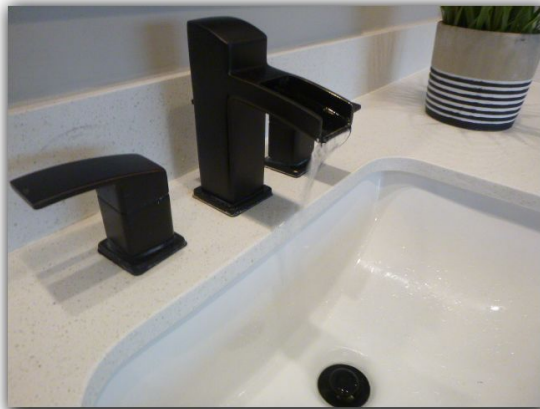
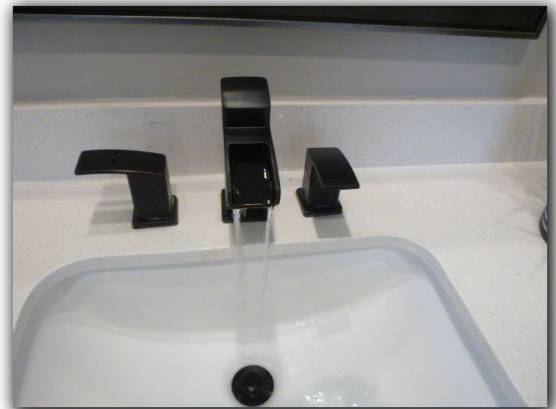
**Very low water pressure observed at one or more faucets; master bathroom both sinks.**

- ◆ **Very low water pressure observed at one or more faucets; master bathroom both sinks**
- ◆ Faucet stop broken, [turns 360°]; master bathroom right sink left handle

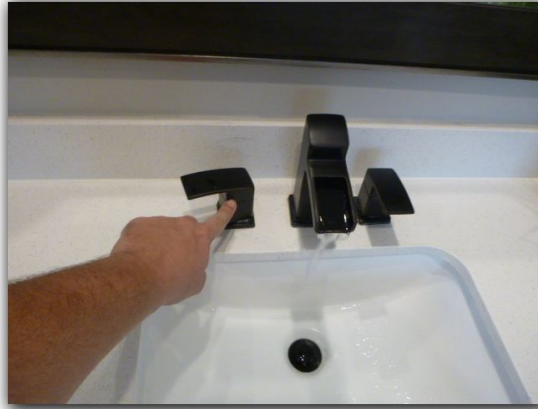
Faucet stop broken, [turns 360°]; master bathroom right sink left handle

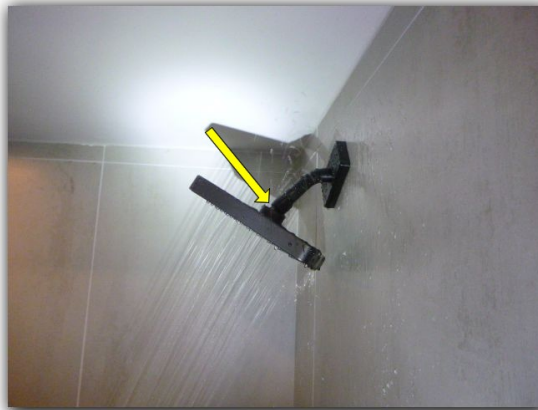
First floor guest bathroom shower head leaks water. Does not appear to be properly installed.

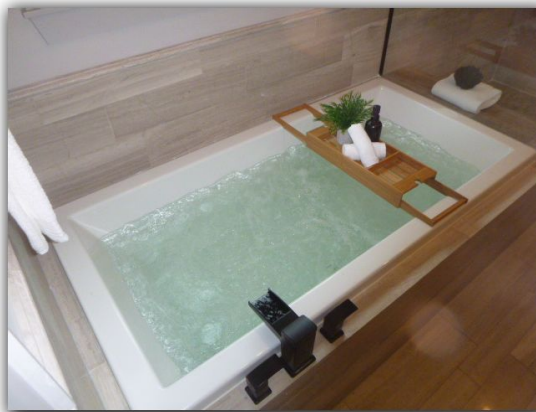
The motor was not accessible for visual inspection. Inaccessibility does not fully comply with the National Electric Code (Reference NEC 680-72. Accessibility. "hydromassage bathtub electrical equipment shall be accessible for repair/replacement without damaging the building structure or building finish".) Should have access panel installed for servicing/access to pump motor IRC 4109.3.

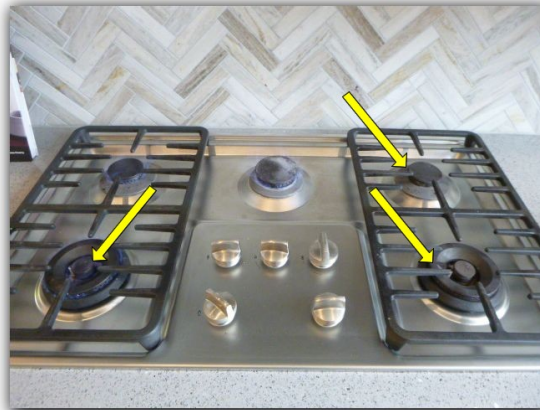
Multiple burners do not self light properly. Do not appear to operate properly. (front left, rear right and front right burner)

- ◆ Multiple burners do not self light properly. Do not appear to operate properly. (front left, rear right and front right burner)

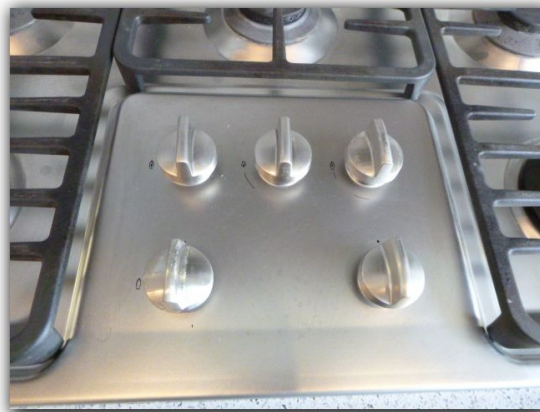
Control knob(s) markings are not legible.

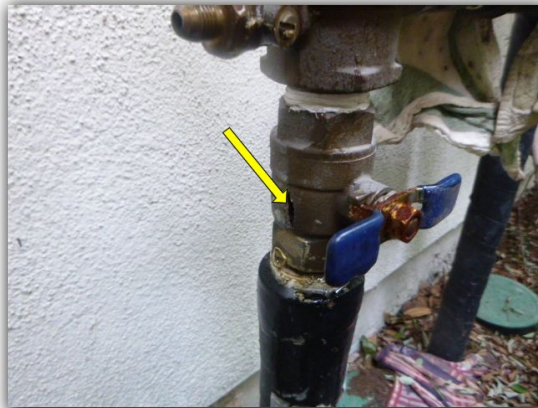
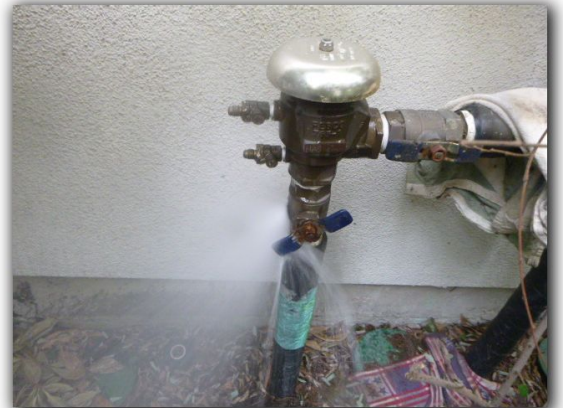
**Backflow prevention device observed to be severely cracked. Needs to be replaced/repair.**

- ◆ **Backflow prevention device observed to be severely cracked. Needs to be replaced/repair.**
